Assessment of the Lawrence Berkeley National Laboratory Aerosol-Based Duct Sealing Technology

Prepared for:
Conservation Services Group,
Pacific Gas and Electric Company
and
Wisconsin Public Service

Final Report
May 16, 1996

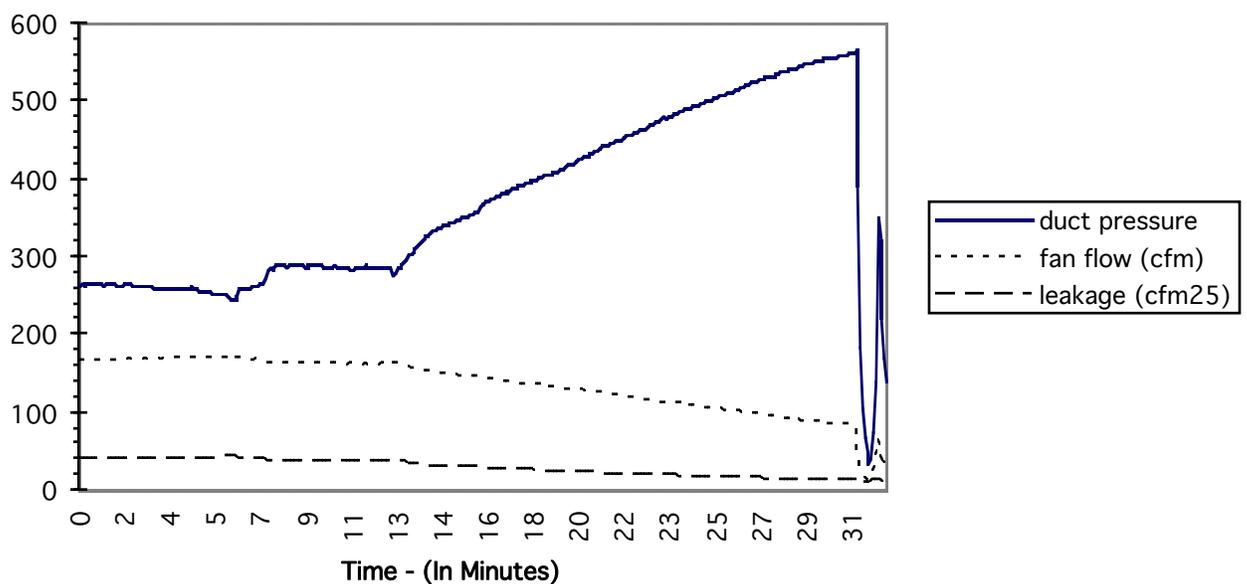
CALIFORNIA - HOUSE # 1

- Aerosol injection point at supply register (no access to supply plenum).
- All register seals held tight, no odor of aerosol in living space.
- Furnace failed to pass the initial combustion safety check on the house. The furnace was creating 2000+ ppm CO.

- Supply system operating pressure found to be 190 pascals. The reason for the high operating supply system pressure is believed to be because the house only had 4 supply runs for a 100,000 btu/hr furnace.

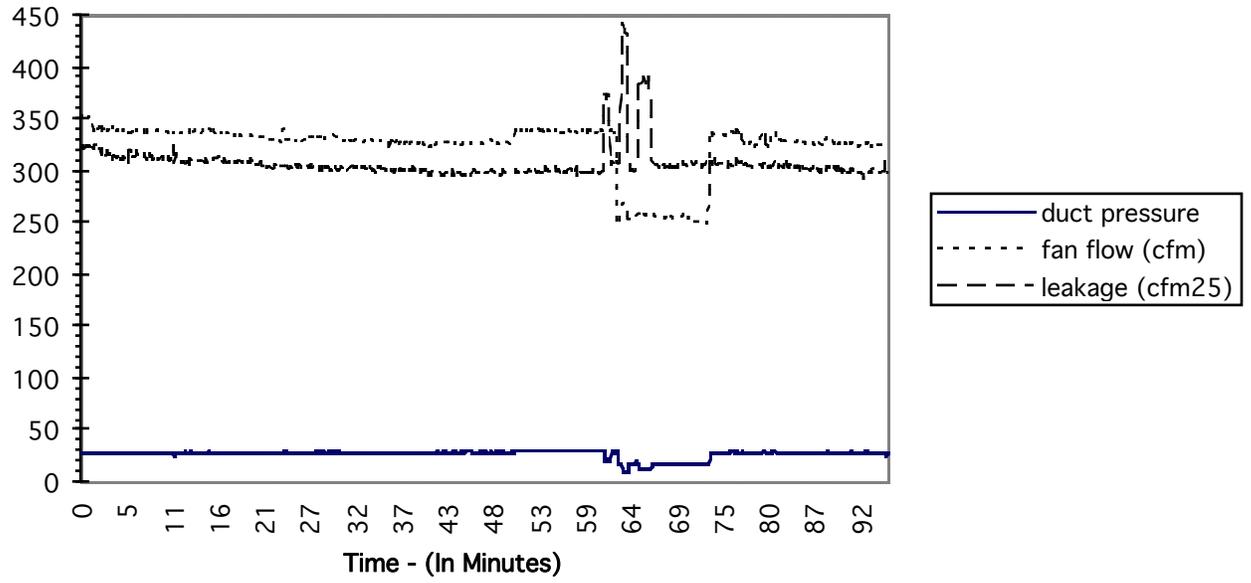
Figure A-2
California House # 2

- Aerosol injection point at supply register (no access to supply plenum).
- All register seals held tight.
- * Odor of aerosol in living space.
- Duct system not effectively sealed due to large leakage areas in a portion of the crawl space that was not accessible.

* The aerosol particles were obviously present in this house during the sealing process due to several mistakes made by the crew. First the combustion air vents and the gap in the flooring around the supply plenum allowed sealant from the crawl space to come into the house. The second mistake was leaving the crawl space access hatch open while the crew was in the crawl space looking for large leaks to seal. This resulted in an aerosol fog coming into the house.

The aerosol sealing process was abandoned after it was apparent that no CFM drop or duct pressure increase was occurring. Also the customer requested that the process be stopped because he said he felt a tightness in his chest that he associated with the aerosol. The customer later reported that his wife had experienced an allergic reaction to something in the house after the aerosol sealing process that he attributed to the sealant being allowed into the living space. He reported that after the house was given a thorough cleaning his wife's allergic reaction went away.

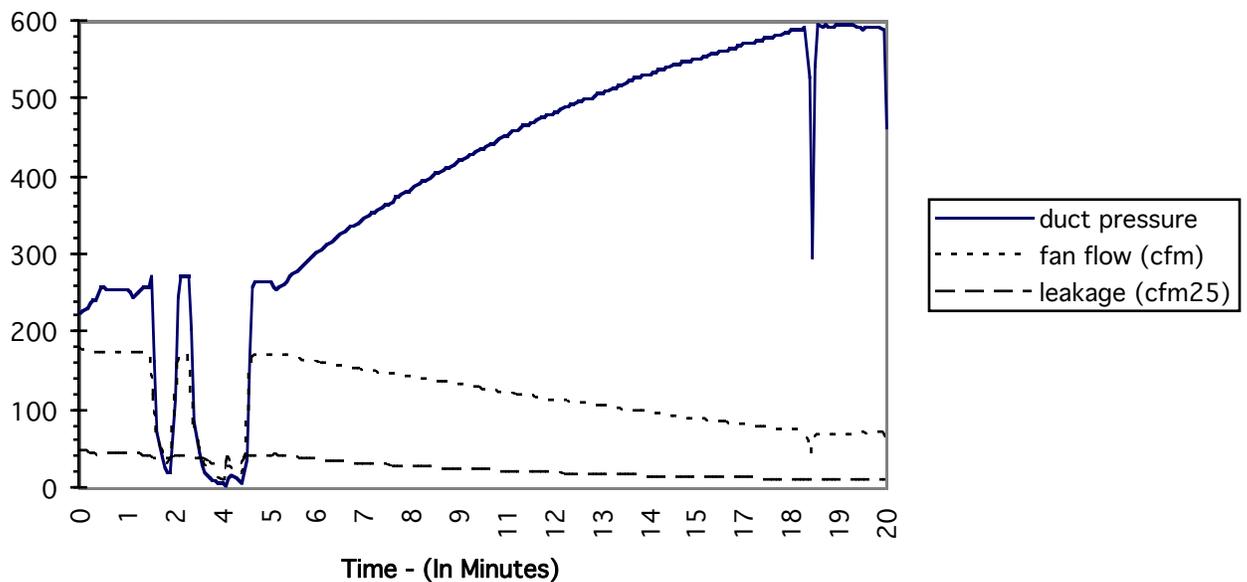
Figure A-3
California House # 4

- Aerosol injection point at supply register (no access to supply plenum).
- All register seals held tight.
- No odor of aerosol in living space.

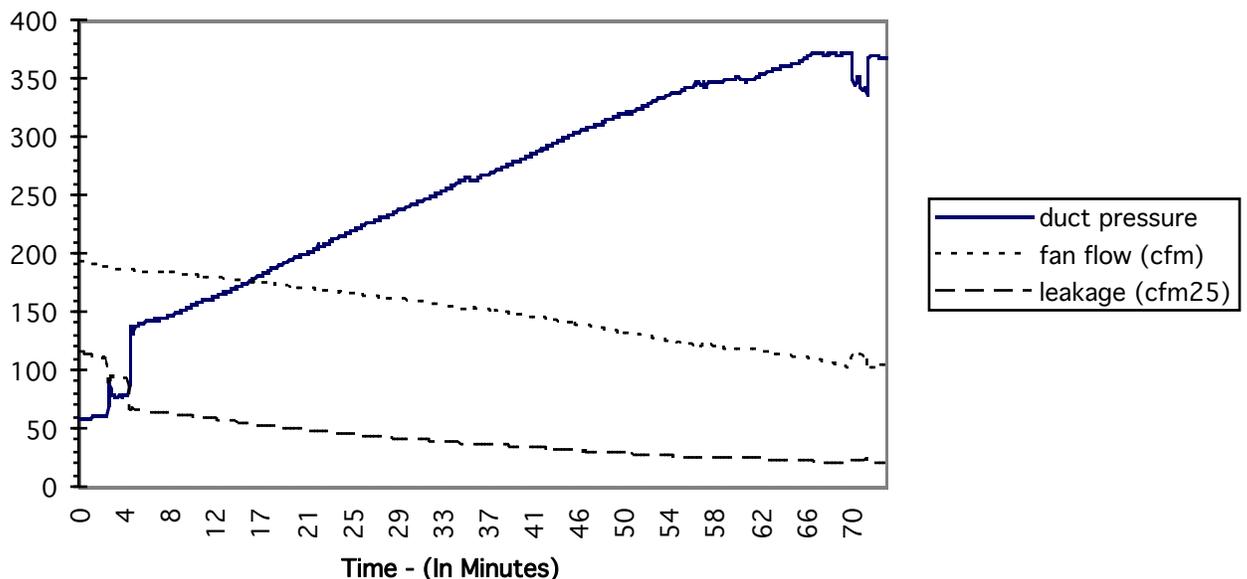
Figure A-4
California House # 5

- Single story house with 1700 square foot of living space.
- The supply duct system had been installed 5 years ago and was sealed with an epoxy type of tape (not butyl backed metal tape).
- A horizontal furnace located in the attic.
- Flexible duct supply system located in the attic.
- 9 supply registers located in the ceiling.
- Supply system chosen for sealing (single return system with short return run).
- * Registers sealed duct mask, pans and extending poles.
- ** Furnace blockage completed by removing the end cap on the supply plenum and blocking the junction of the supply plenum to evaporator coil cabinet with cardboard, screws and duct tape.
- Aerosol injection point at supply register (no access to supply plenum).
- Slight odor of aerosol in living space due to leakage at pans.

* All registers were all blocked using the duct mask, pans and poles. This system worked okay but it was very hard to get a good seal if there was something directly below the register that caused the pole to have to be installed at an angle (e.g. bath vanity). The other problem encountered was the slits created in the duct mask sealed themselves and the pressure started coming out behind the duct mask (between the duct mask and the ceiling surface). Learned that there must be holes created in the duct mask not just slits. Also have some concerns about using duct mask on sprayed acoustical ceilings. It tends to pull a lot of the material off and if there was any weakness at that area the entire duct mask area may pull off. Also had problem getting good pan seals on sprayed ceiling.

** The end cap then had to be reinstalled for the sealing process. This was very time consuming due to difficulty in replacing the end cap and the difficult access to the supply plenum in the small attic space.

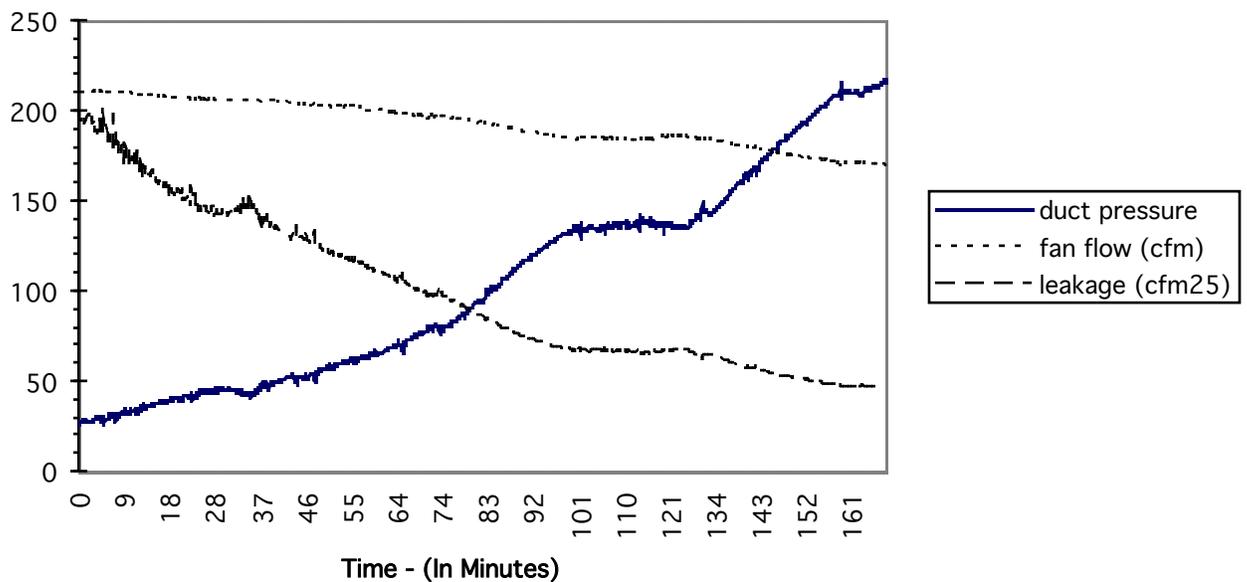
Figure A-5
California House # 6

The crew had trouble with the liquid injection on this house. There was a substantial puddle of liquid in the lay flat tubing and the nozzle was almost completely clogged after one hour of operation.

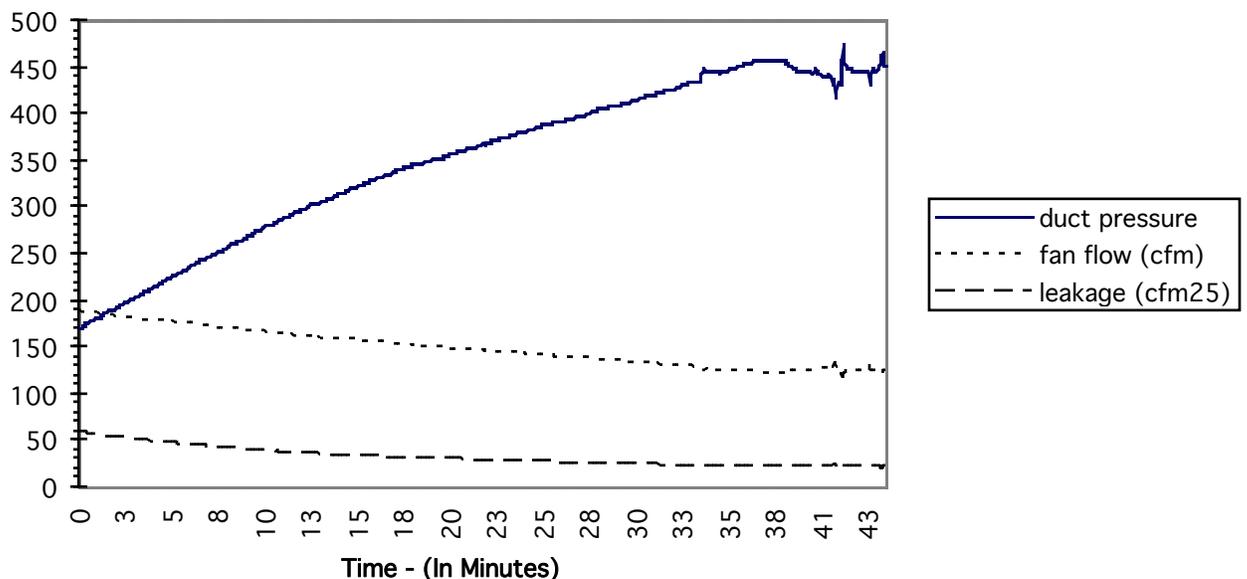
Figure A-6
California House # 8

* A wall register seal failed at higher pressures, so the system was not sealed as tight as some of the other systems. The duct mask, pan and LBNL tensioner didn't work that well. The tensioner couldn't be pulled tight enough seal to stop the leakage between the duct mask and foam strip on pan.

** This was the hardest system encountered for blocking between the evaporator coil and supply plenum. Coil sits under furnace and the only way to block it was to cut out the sheet metal front on the coil (could not be removed whole because of refrigerant distribution tubing) and seal it by slipping card board under the coil and taping from inside of coil. Very time consuming and not a method that is suggested unless the person knows how to work around refrigerant coils.

*** No fogging of house but you could smell sealant in the kitchen where there was a kick space register that had to be sealed at the register because the register couldn't be pulled.

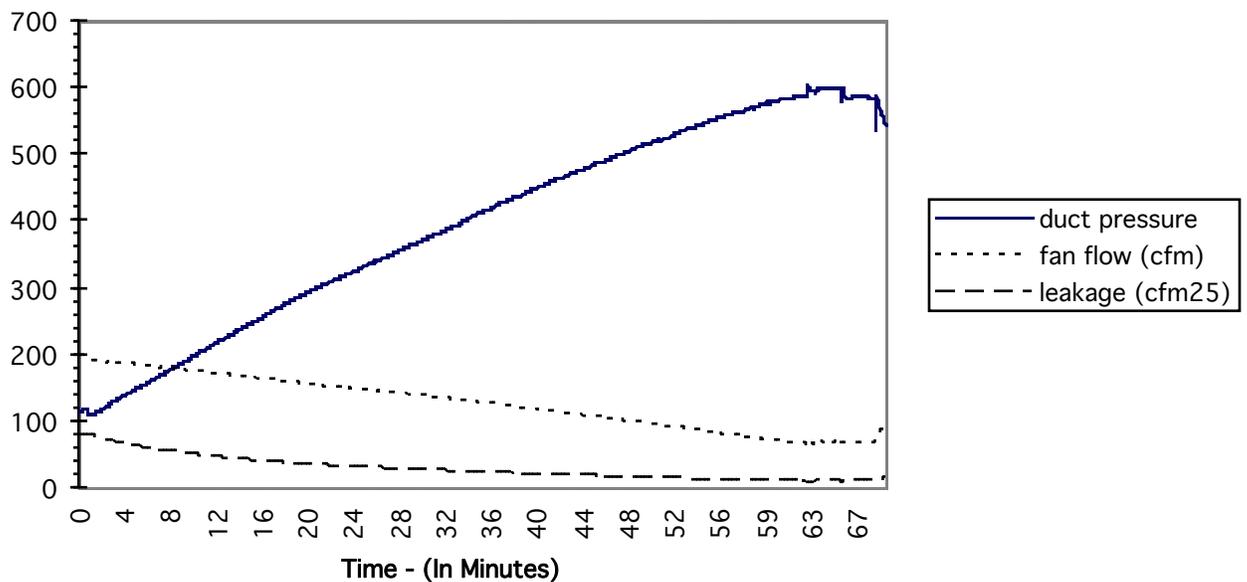
Figure A-7
California House # 10

- 6 supply registers located in the floor on a trunk and branch system.
- Return system used two grilles that fed into the space between the first and second floor. This return system needed replacement with a ducted system.

- Aerosol injection point at coil cabinet access.
- All register seals held tight.
- No fogging or smell observed.

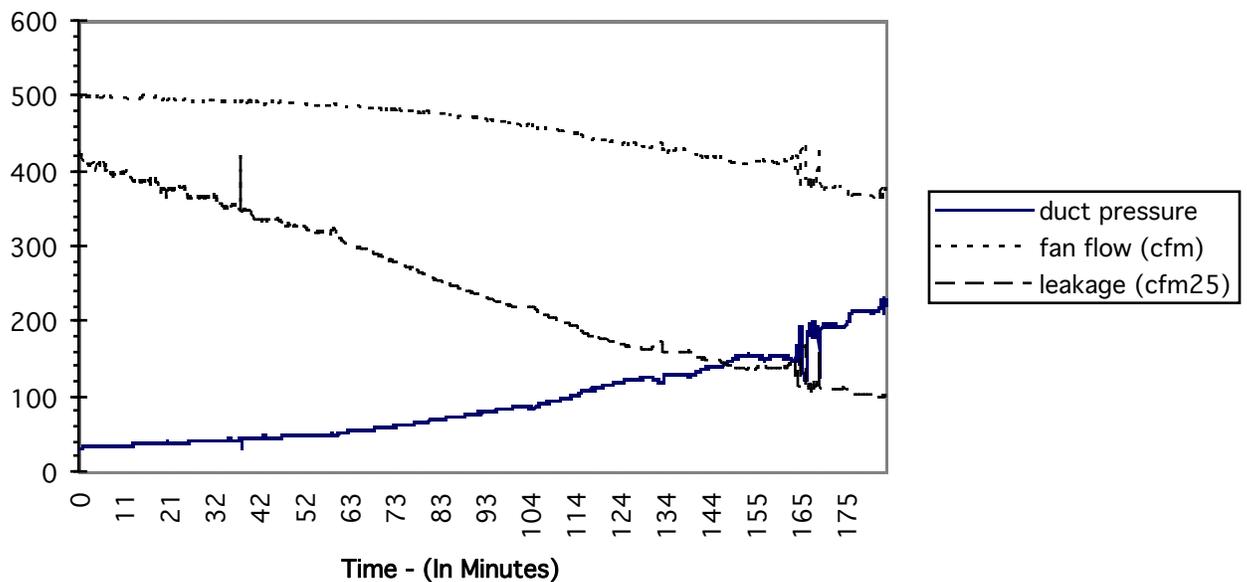
Figure A-8
East Coast House # 2

- Some aerosol odor in the house, lots of fogging in the basement.
- Register seals held tight but the injection point collar did not.
- Air in liquid injection line caused the sealing process to be slow and contributed to there being a large accumulation of liquid puddled in the lay flat tubing.

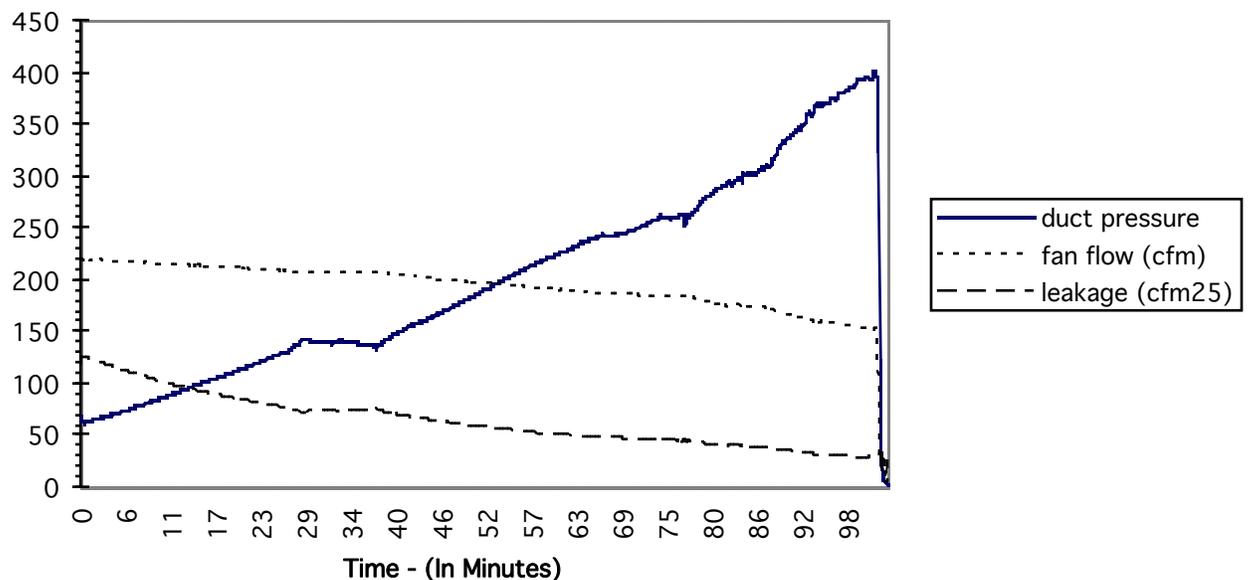
Figure A-9
East Coast House # 3

- Some aerosol odor in the house, lots of fogging in the basement.
- Register seals held tight.
- * Air in liquid injection line caused the sealing process to be slow and contributed to there being a large accumulation of liquid puddled in the lay flat tubing.

* The reason for the air in the liquid injection line was discovered to be a loose fitting at the liquid reservoir. The fitting was sealed with silicone caulk and the problem with air in the liquid line was solved.

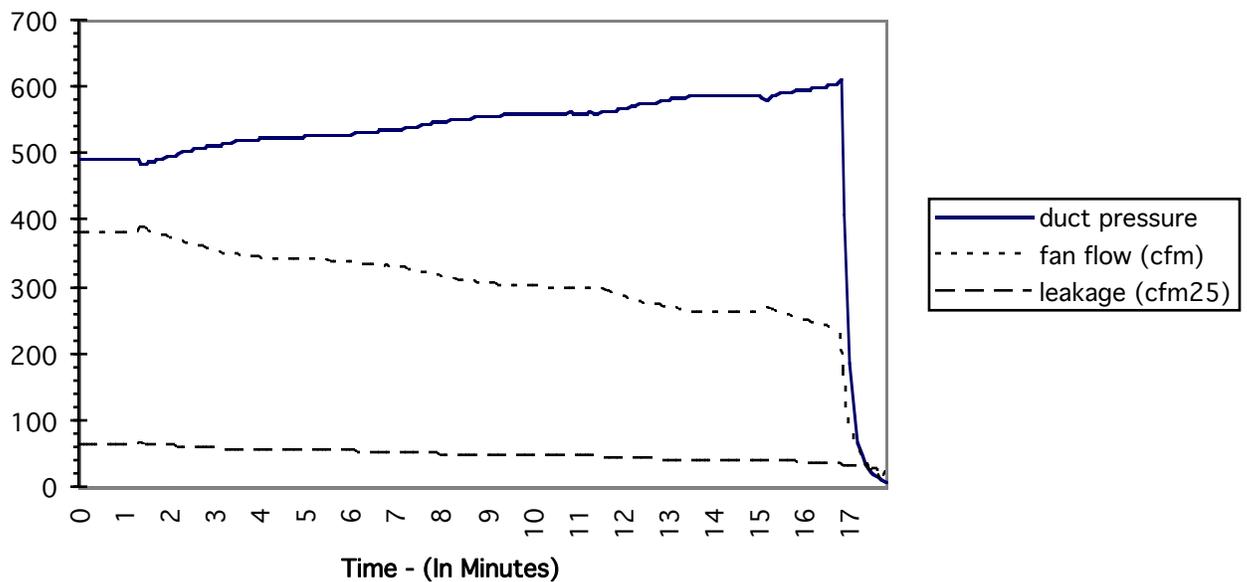
Figure A-10
East Coast House # 4

- First floor apartment with 750 square foot of living space.
- The duct system had not previously been sealed.
- An upflow furnace located in the unconditioned basement.
- Sheet metal duct system.
- 5 supply registers located in the floor.
- Supply system chosen for sealing.
- Registers sealed with duct mask, cardboard and extending poles to hold in place. Furnace blockage completed by cutting hole in supply plenum and blocking with cardboard and duct tape.
- Aerosol injection point at supply plenum access hole.
- Some aerosol odor in the house.
- Test results are inaccurate due to a pinched hose. Sealing process graph covers only the last eighteen minutes of aerosol injection.

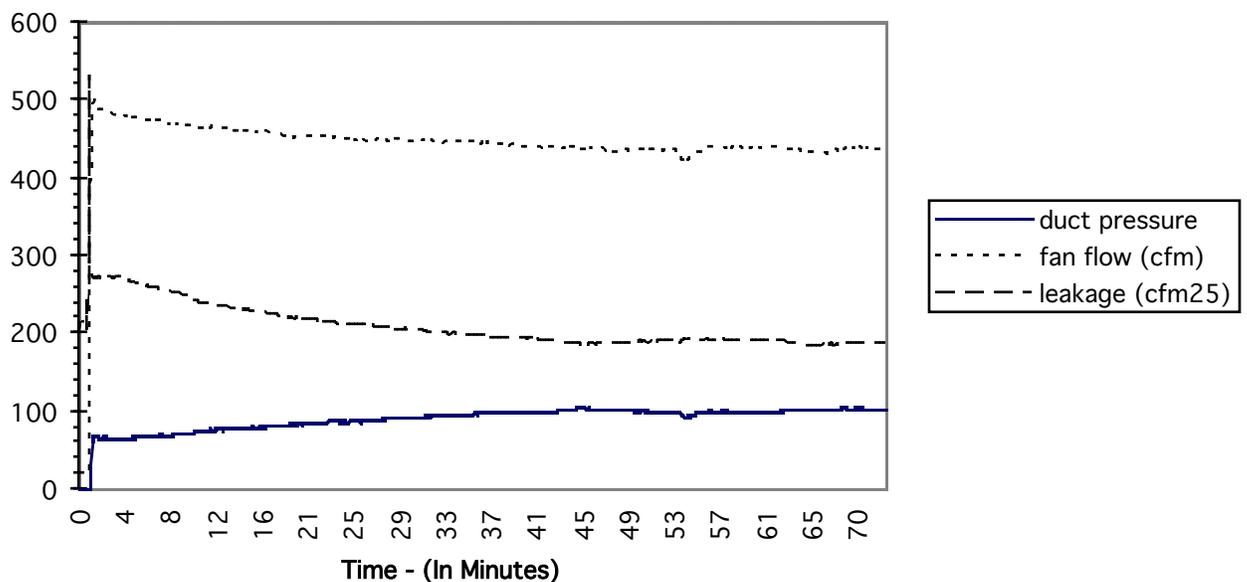
Figure A-11
East Coast House # 5

- Some aerosol odor in the house from the leaking register seals.
- * Injection process had to be stopped before the duct system was completely sealed due to running out of sealant.

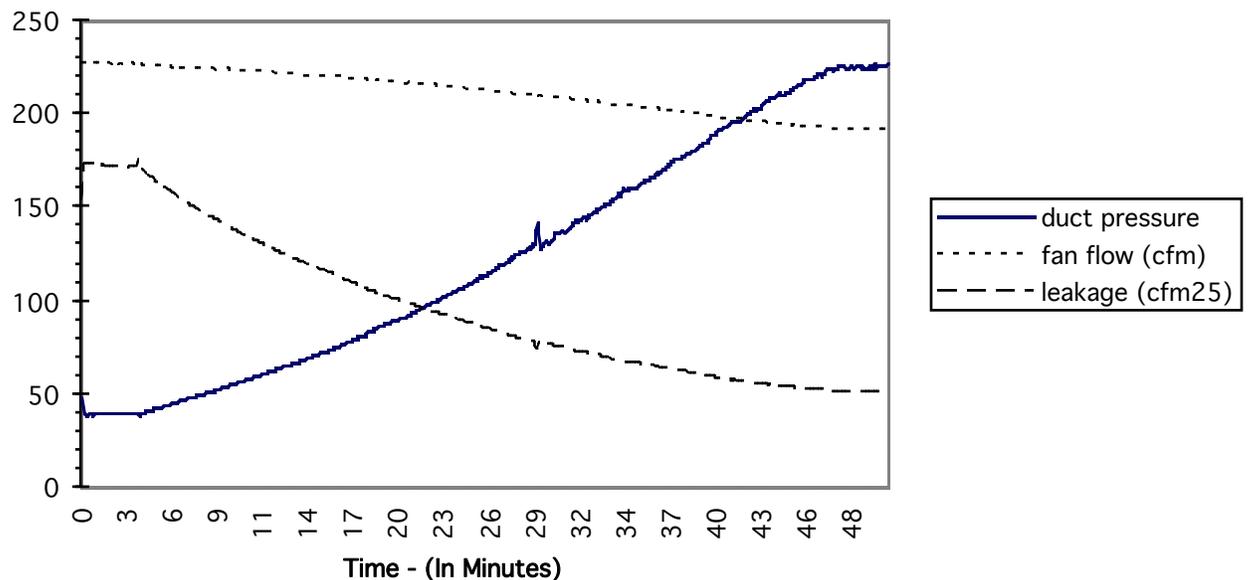
Figure A-12
East Coast House # 6

- Two story house with 1400 square foot of living space.
- One of the return ducts had previously been sealed.
- An upflow furnace located in the unconditioned basement.
- Sheet metal duct system.
- 11 supply registers located in the floor and the walls.
- Supply system chosen for sealing (due to return system sealing).
- Registers sealed with cardboard inserted under the carpeting with either weights or extending poles to hold in place. Wall registers sealed with duct mask, pans and LBNL tensioning device. Baseboard registers were sealed by cutting cardboard to fit inside of register opening and taping in place.
- Furnace blockage completed by cutting hole in supply plenum and blocking with cardboard and duct tape.
- Aerosol injection point at supply plenum access hole.
- No odor of aerosol in living space.

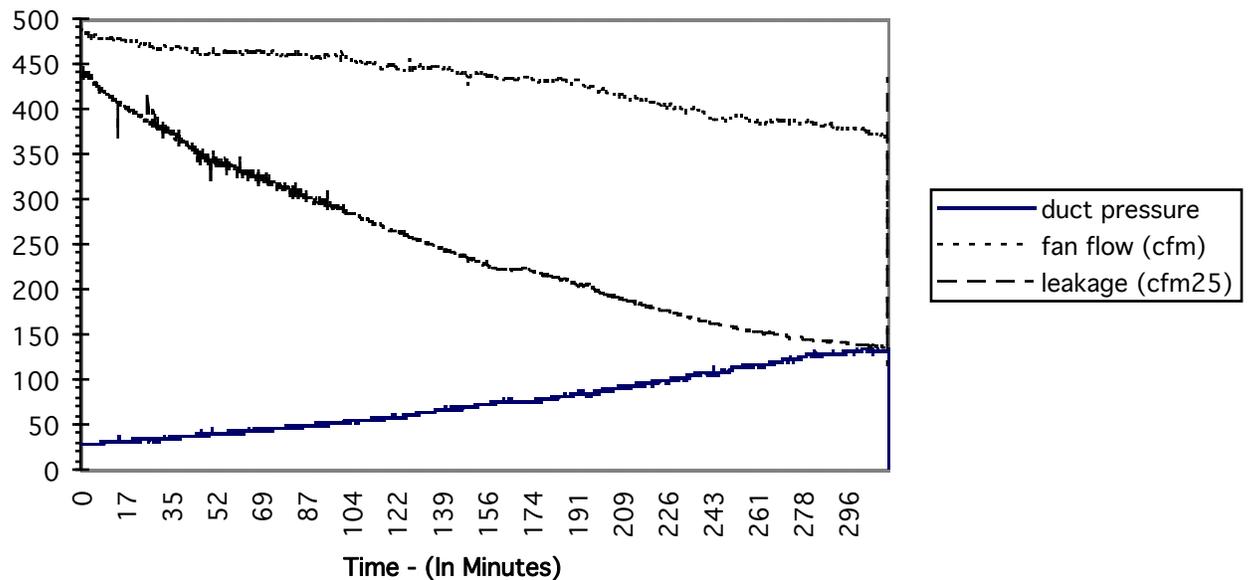
Figure A-13
East Coast House # 7

- Two story house with 2300 square foot of living space.
- The duct system had not previously been sealed.
- An upflow furnace located in the unconditioned basement.
- Duct system consist of sheet metal ducts in the basement with some flex duct runs to the second floor.
- 14 supply registers located in the floor.
- Supply system chosen for sealing (small return system).
- Registers sealed with cardboard inserted under the carpeting with either weights or extending poles to hold in place.
- Furnace blockage completed by cutting hole in supply plenum and blocking with cardboard and duct tape.
- Aerosol injection point at supply plenum access hole.
- No odor of aerosol in living space. Lots of fogging in the basement.
- Long injection time believed to be due to leaks around boots that were not sealed prior to injection.

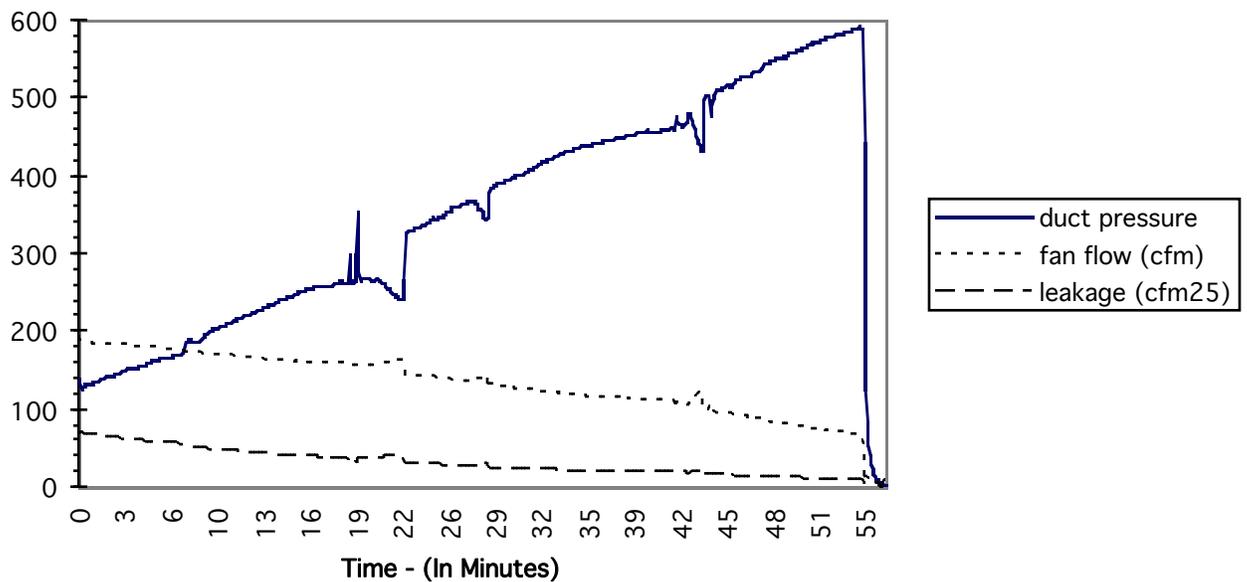
Figure A-14
East Coast House # 8

- Second floor townhouse with 800 square foot of living space.
- The duct system had not previously been sealed.
- A horizontal heat pump located in the attic.
- Duct system consist of sheet metal ducts in the attic.
- 10 supply registers located in the ceiling and walls (2).
- Supply system chosen for sealing (only one central flex duct run on return).
- Ceiling registers sealed with duct mask, cardboard and extending poles to hold in place. The wall registers were sealed in the same fashion.
- Furnace blockage completed by cutting hole in supply plenum and blocking with cardboard and duct tape.
- Aerosol injection point at supply register (not enough room for a straight run in attic).
- No odor of aerosol in living space.

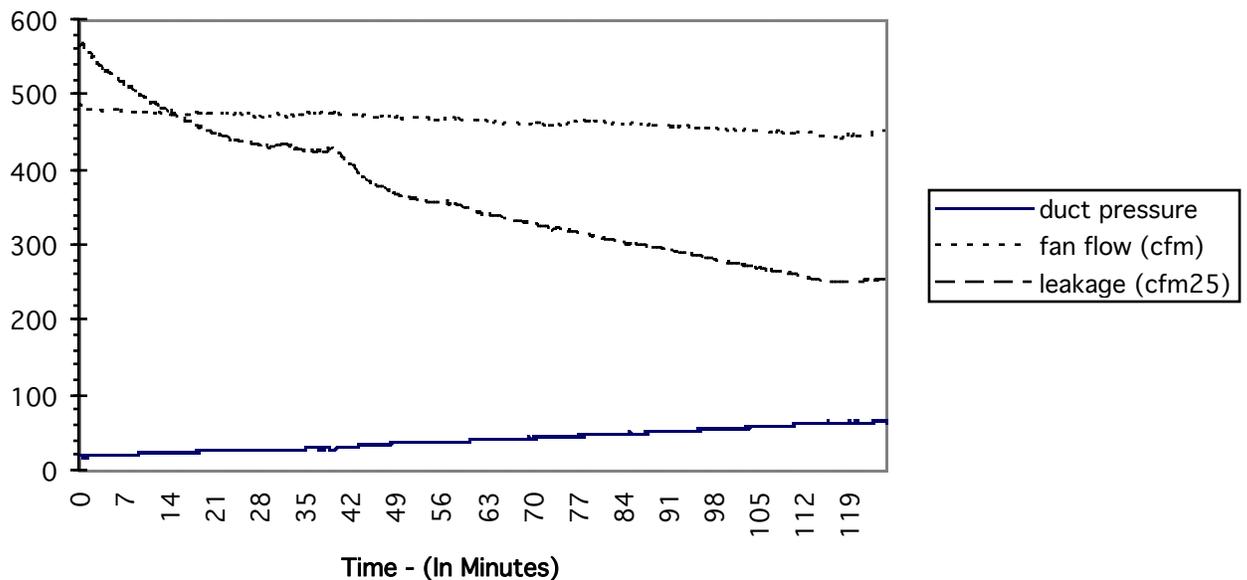
Figure A-15
Wisconsin House # 1

- Two story, three bedroom house.
- The duct system had not previously been sealed.
- An upflow furnace located in an unconditioned basement.
- Duct system consist of sheet metal ducts in the unconditioned basement and metal duct runs in wall cavities to the second floor.
- 8 supply registers located on the interior walls.
- 6 return grilles located in the baseboards on exterior walls
- Return system chosen for sealing (house pressure imbalance test indicated it was the leakier system).
- Baseboard registers sealed by cutting cardboard to fit inside of boot opening and duct taped in place
- Furnace blockage completed by cutting hole in return plenum and blocking opening to furnace with cardboard and duct tape.
- Aerosol injection point at access hole cut in return plenum.
- * Slight odor of aerosol in living space. Extensive fogging in basement.

* There were 6 panned floor joist spaces for the return in the basement. All of these floor spaces had large amounts of leakage at the spaces between the sub-flooring boards (approximately 1/2 to 1 inch space between the sub-flooring boards) where they met the joist. The spaces between the sub-flooring boards were sealed with caulking. Even with a scrubber fan running there was a lot of fog visible in the basement.

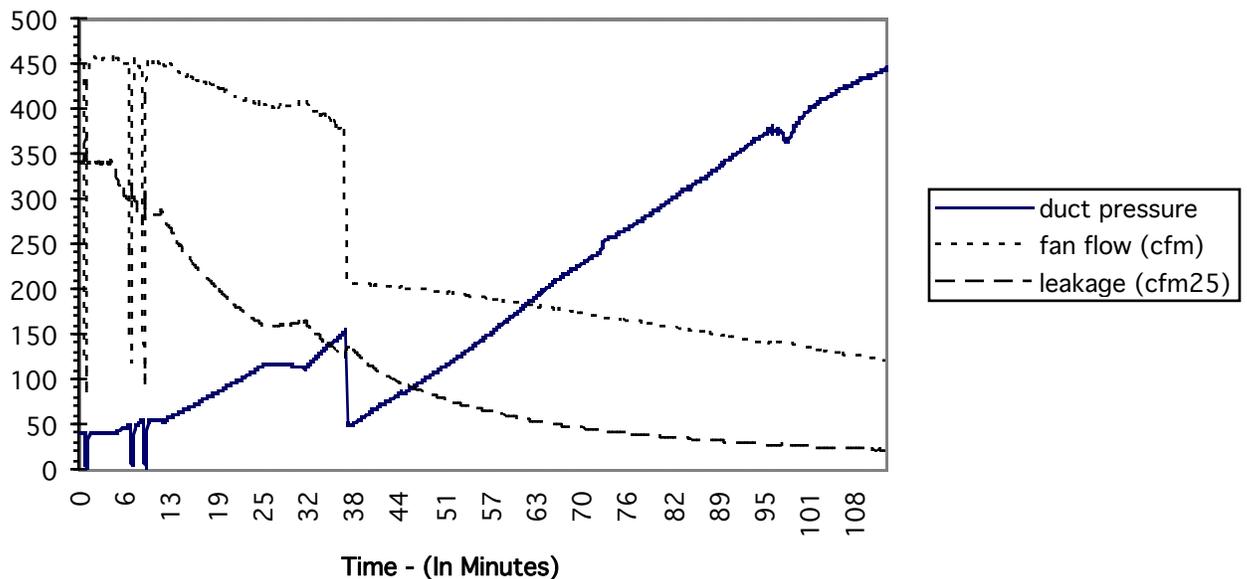
Figure A-16
Wisconsin House # 2

- Aerosol injection point at access hole cut in extended supply plenum.
- Slight odor of aerosol in living space. Extensive fogging in basement.

The basement was all on one breaker so power for the aerosol injection machine had to be gotten from upstairs so that the lights and the scrubber fans could be left on in the basement.
