Prepared by:
Proctor Engineering Group, Ltd.
San Rafael, CA 94901
(415) 451-2480

Investigation of Coil Failures - A Whole Systems Approach

Prepared for:
Geothermal Heat Pump Consortium

**Final Report
July 1998**

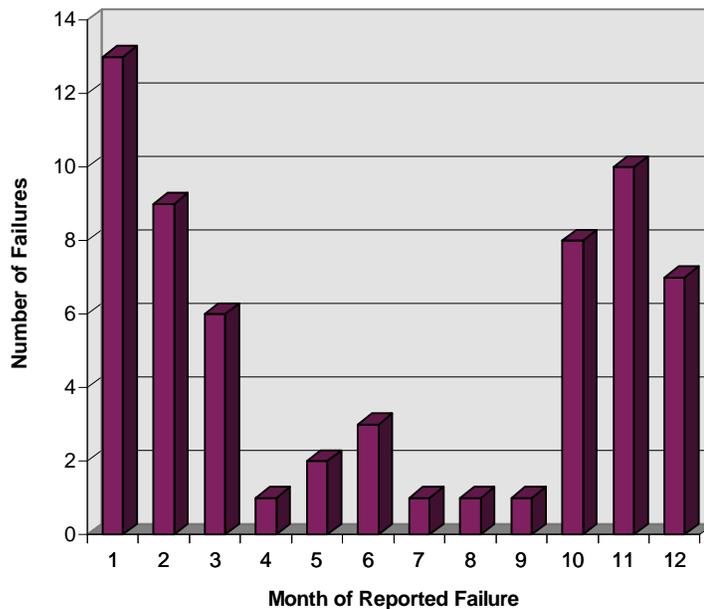
Figure 1. Month of Reported Coil Failure

Prior to the site visits, Proctor Engineering reviewed metallurgy reports on the coil failures as well as warranty and service data available for the homes in the development. Figure 1 shows the number of failure incidents in each month for a sample of 64 ground source heat pumps with warranty reports. Twenty of the units had no reports of coil failures, while the remaining 44 had 62 reported coil failures. Some of the homes in the investigation also had service records which showed additional coil failures not recorded in the warranty data.

These heat pumps are used less in heating than they are in cooling and the electrical bills reflect this. Nevertheless, the coil failures were substantially higher in the winter. The hypothesis that the corrosion occurred in the summer with higher winter coil pressures causing the refrigerant leaks was examined in light of this data. While there is a peak at winter startup (October and November), the higher failure rates in January and February do not support that hypothesis. The data supports the hypothesis that corrosion is present in the winter as well as summer.

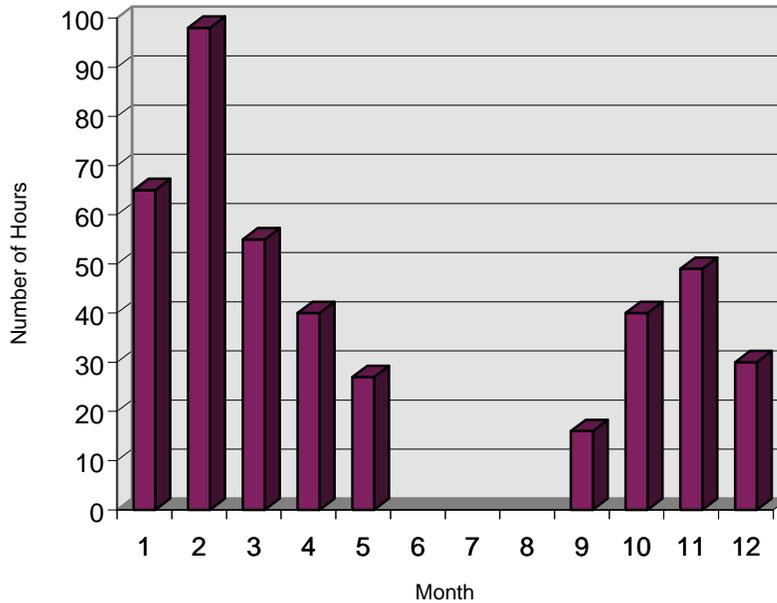
Figure 2 Hours with Outdoor Temperature <60°F and Dew Point >50°F (Average Year)

This area has an average of 337 winter hours with an outdoor dry bulb temperature less than 60°F and an outdoor dew point of over 50°F. These are hours with high potential for corrosion due to moist coil conditions. The distribution of these hours in an average year is shown in Figure 2.
